ACCIDENT No. 45-8-15-532

REPORT OF AIRCRAFT ACCIDENT

(1) Place AAF Station No. 106, England (2) Date 15 August, 1944 (3) Time 1320
 AIRCRAFT: (4) Type and model E-17G 090 (5) A. F. No. 44-8011 (6) Station 106
 Organization: (7) 8th (8) 384th Bomb (H) (W) (9) 547th Bomb (H)
 (Command and Air Force) (Group) (Squadron) 2357

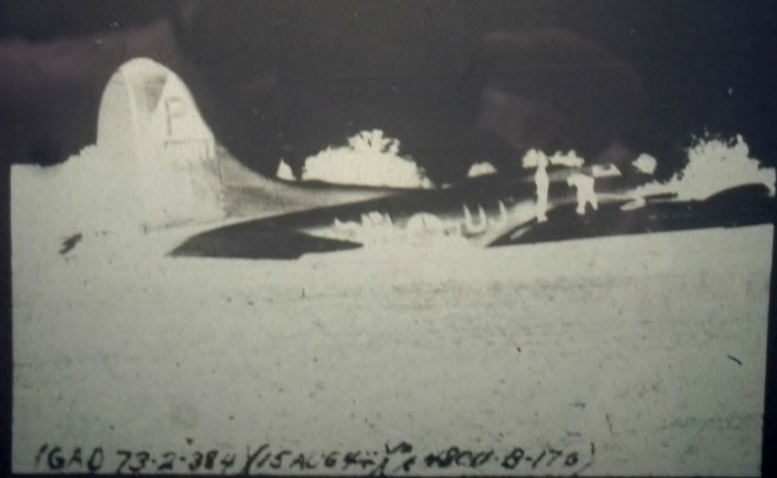
While the A/C were moving around the perimeter track to a new take-off position, Lt. Rainey's A/C lost its hydraulic pressure. To avoid hitting another A/C he swerved off the perimeter track into a small gully, hitting a hedge and fence.

1. At approximately 1355 hours, 15 August, 1944, B-17 #8011, pilot Rainey rolled off the perimeter track opposite disp 42 through a hedge, and came to rest on a spot of low ground north of the hear glass dispersals 36 to 39.

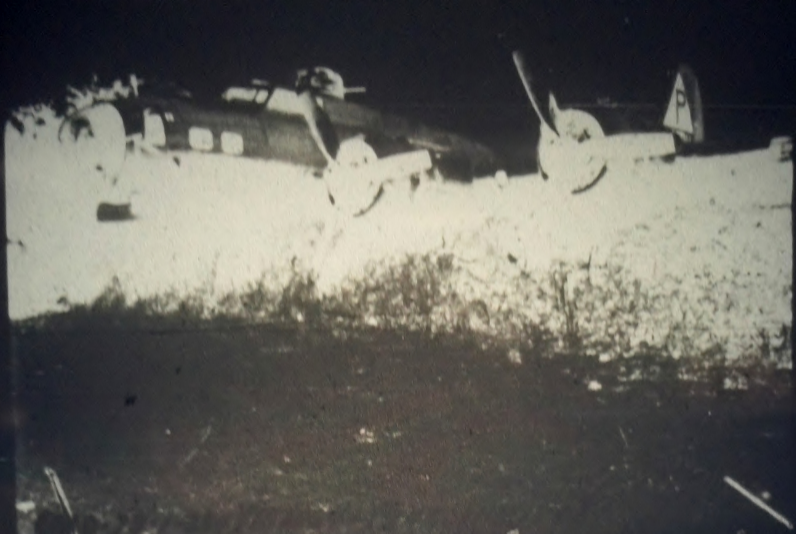
DAMAGE	(46) LIST OF DAMAGED PARTS
(46) Aircraft <u>M 4</u>	<u>Right outer wing panel; left landing flap; rudder;</u>
(47) Engine(s) <u>1 1 1 1</u>	<u>fuselage stations 2, 3, 9, 10, 11; tail gunner's compart-</u>
(48) Propeller(s) <u>1 1 1 1</u>	<u>ment damaged.</u>
