ACCIDENT No.

45-10-10-524

REPORT OF AIRCRAFT ACCIDENT

AIRCRAFT: (4) Type and model B-17-G (5) A. F. No. 42-37788 (6) Station AAF Station 106

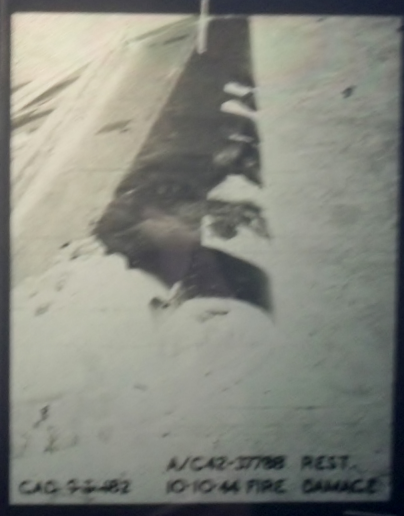
CAC 92482

A/C42-37788 REST.  
10-10-44 FIRE DAMAGE
