ACCIDENT NO. 45-1-1-524

REPORT OF AIRCRAFT ACCIDENT

(1) Place AAF STATION NO. 106 (2) Date 1 January 1945 (3) Time 0815
AIRCRAFT: (4) Type and model B-17G (5) A. F. No. 43-38801 (6) Station AAF No. 106
Organization: (7) 8th (8) 38th Bomb (H) (9) 54th Bomb (H) (10) 2357
(Command and Air Force) (Group) (Squadron)

STATEMENT BY 1ST LT ROBERT J. FISHER, O-706155, CONCERNING
AIRCRAFT ACCIDENT OF B-17G, #43-38801, 1 JANUARY, 1945.

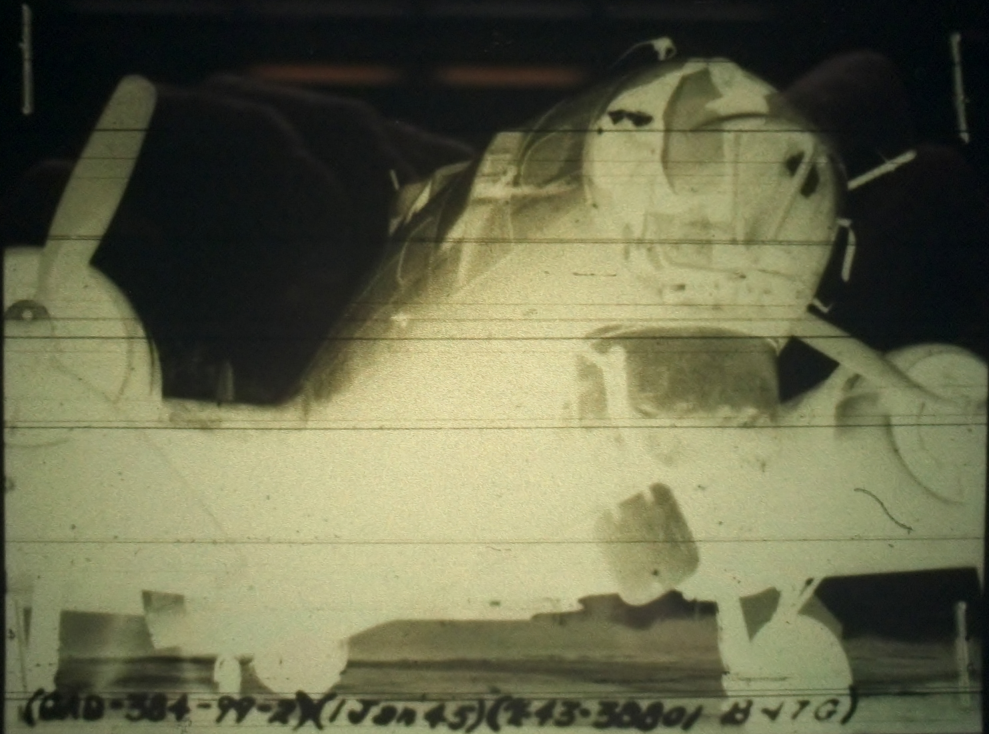
DAMAGE	(46) LIST OF DAMAGED PARTS
(46) Aircraft	Left outer wing panel and tip, No. 1 engine and mount,
(47) Engine(s)	chin turret, plexiglass nose, left and right inner
(48) Propeller(s)	wing panels. Disposition of A/C questionable pending
	decision by 2nd S.A.D.

(57) Cause of accident Aircraft brushed tree tops when pilot maneuvered to prevent collision with what he believed was another aircraft.
