3-23-2162-0 REPORT OF AIRCRAFT ACCIDENT

(1) Place AAF Station No. 107 (2) Date 1 February 1945 (3) Time 1506

AIRCRAFT: (4) Type and model B-17G DO (5) A. F. No. 43-38927 (6) Station AAF No. 106

(53) Nature of accident Landing Accident

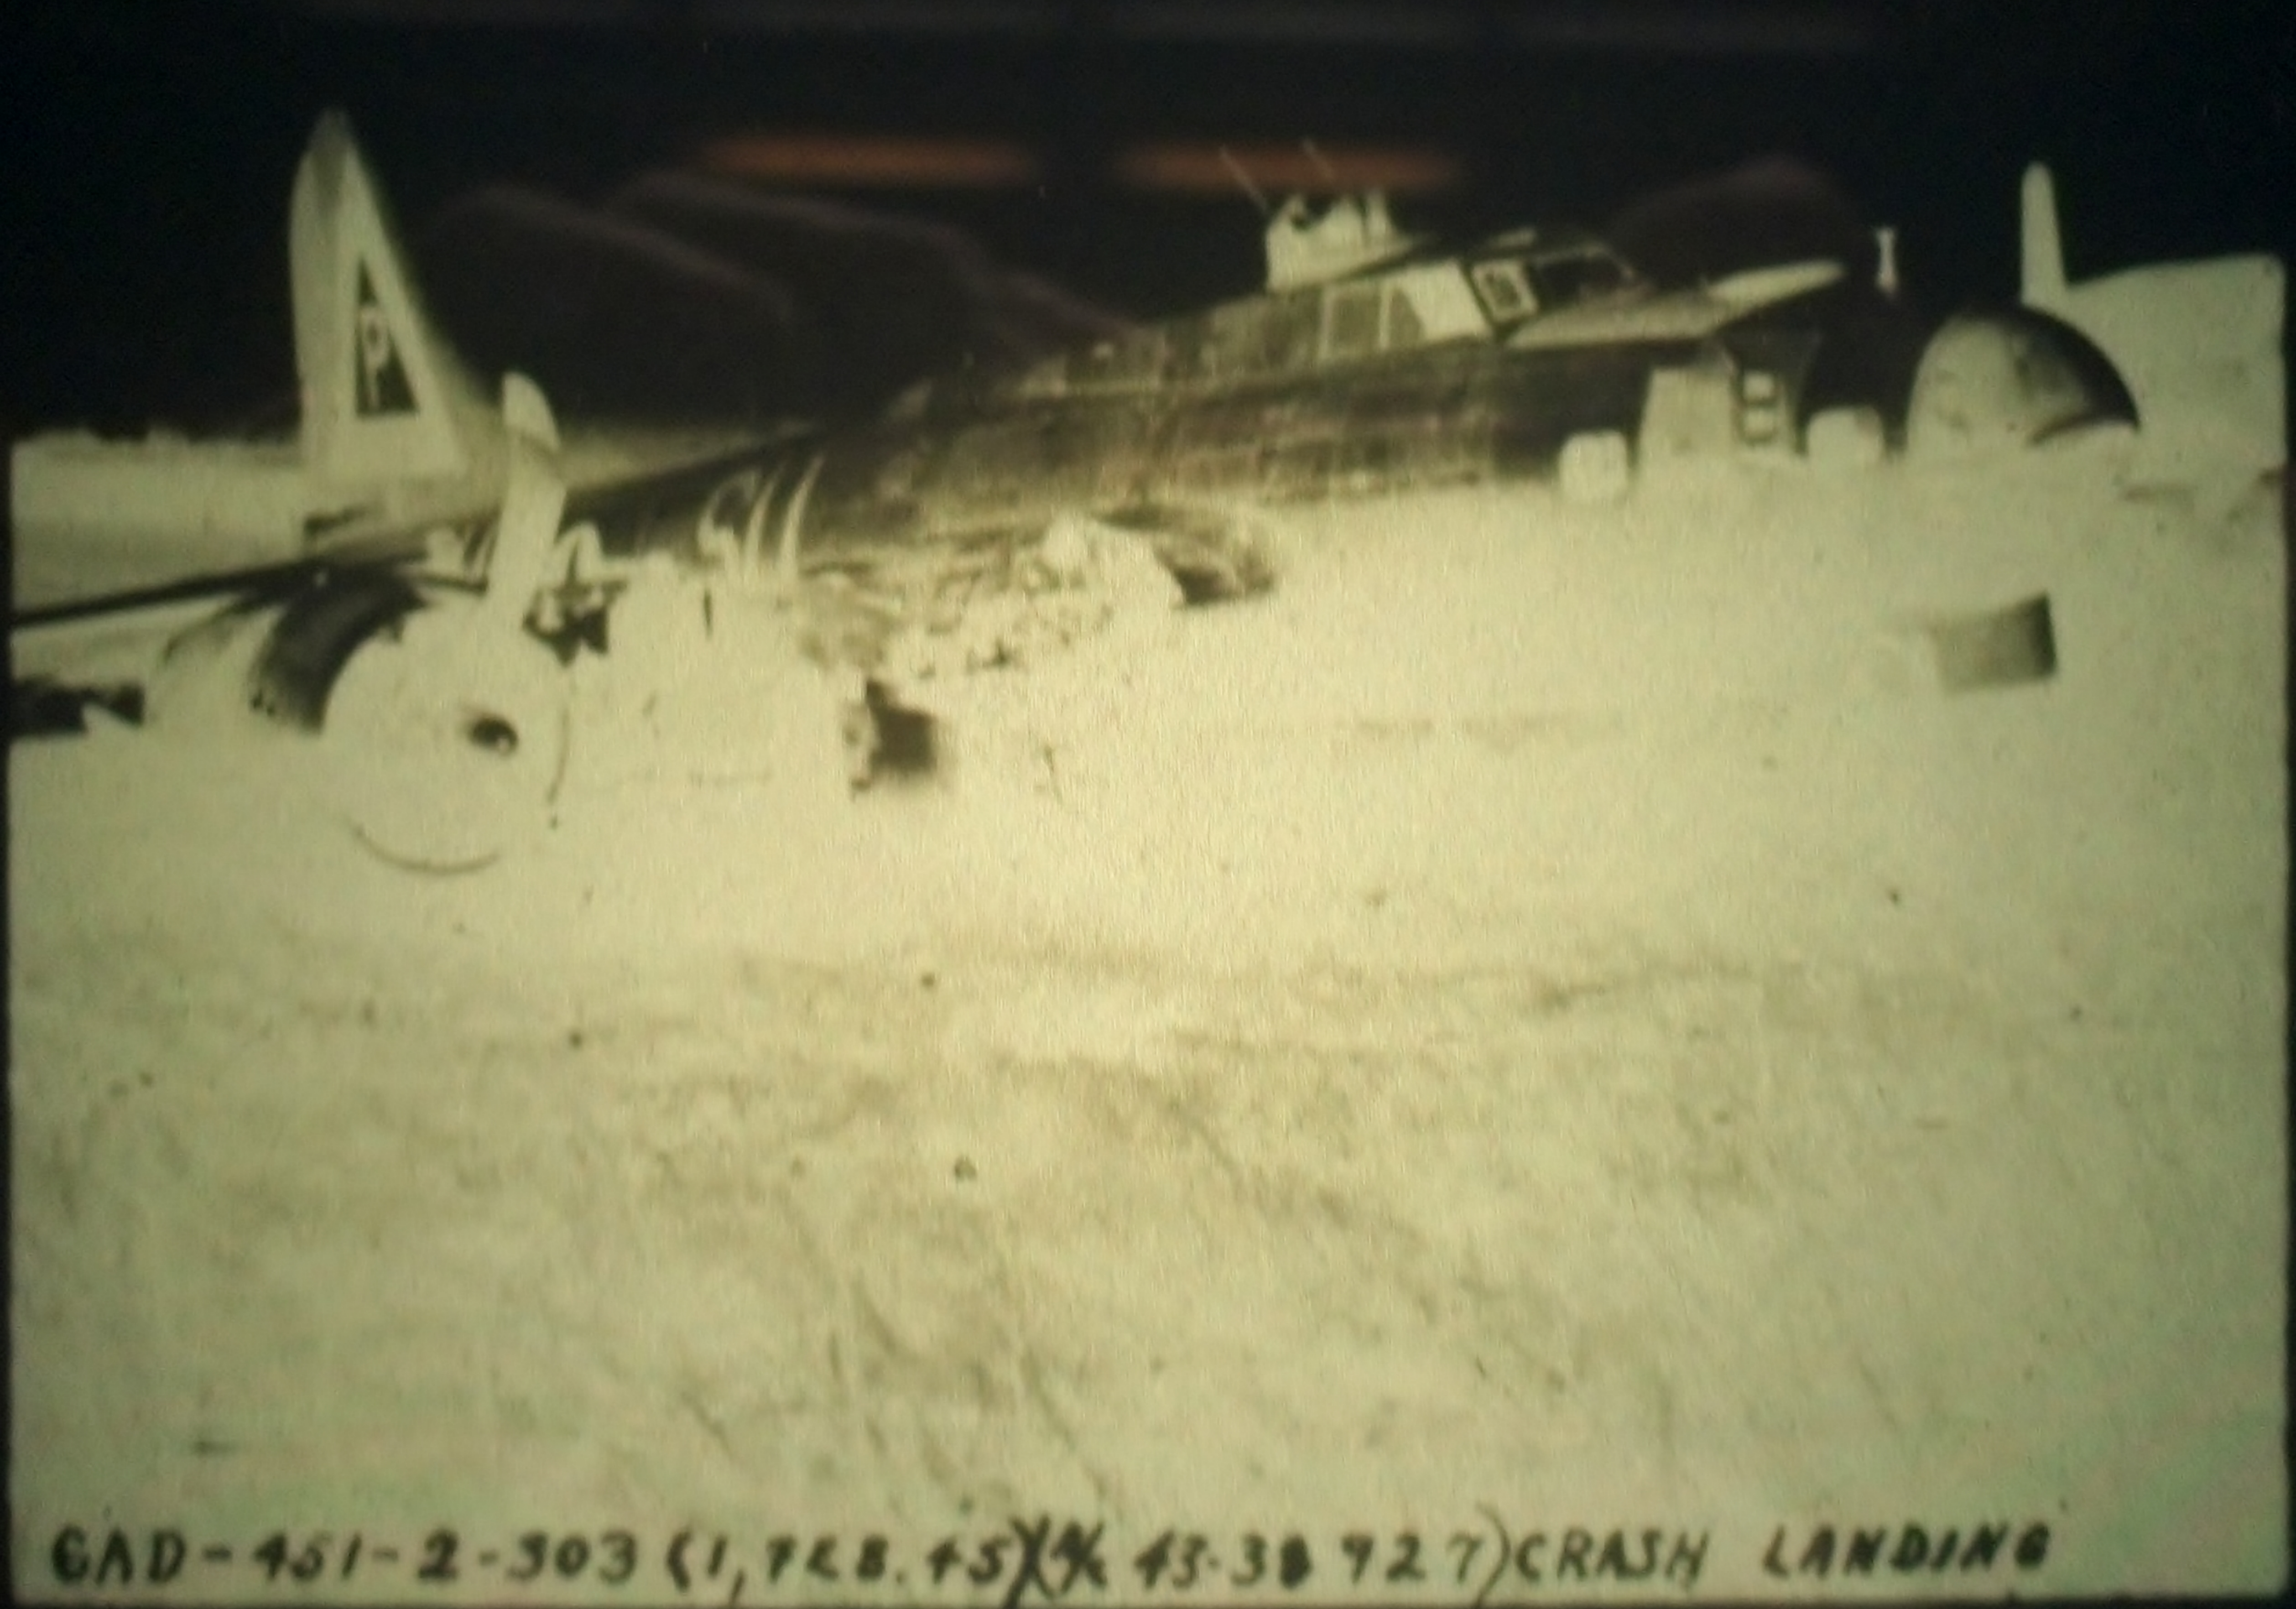
GAD-451-2-303 (1, FEB. 45) (43-38 927) CRASH LANDING

DAMAGE	(49) LIST OF DAMAGED PARTS
(44) Aircraft <u>N</u>	Ball turret salvaged. R. inboard and outboard wing
(45) Engine(s) <u>1</u>	panels damaged. minor damage to left inboard wing
(46) Propeller(s) <u>1</u>	panel.

(54) Cause of accident Landing long on runway with three engines out and right landing gear only partially retracted.

I About 1510 hours, 1 February 1945, aircraft number 43-38927 from AAF Station 106 flew over the field and fired a red red flare. The aircraft proceeded past the field in a Northwest direction, then made a right turn and attempted to land on runway 20. With two engines feathered and his right landing gear only partially extended, he landed about two-thirds of the way down the runway. The partially extended wheel collapsed and he slid off the end of the runway considerably damaging the ship.
