WAR DEPARTMENT
U. S. ARMY AIR FORCES

ACCIDENT No. 457.28-518

REPORT OF AIRCRAFT ACCIDENT

Place AAF Station 106 (2) Date 28 July, 1944 (3) Time 0754

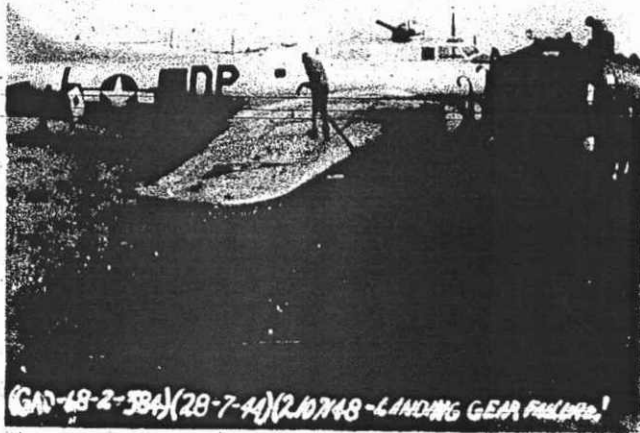
Pilot came in for landing, leveled off approximately twenty (20) feet above runway. Aircraft stalled out, "Dropped in" on right wheel, causing failure of right tire and breaking drag link on right gear.

(64D-68-2-384)(28-7-44)(210748-LANDING GEAR FAILURE)

Other than giving Pilot a thorough indoctrination on landing this type of aircraft no other recommendations are made to prevent repetition in the future.

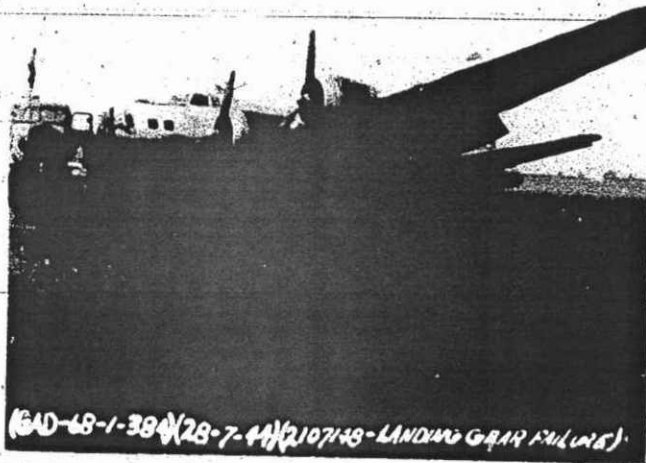
(64D-68-1-384)(28-7-44)(210748-LANDING GEAR FAILURE)
