REPORT OF AIRCRAFT ACCIDENT

45-1-22-526

(1) Place AAF Station 106 (2) Date 22 January 1945 (3) Time 1557  
AIRCRAFT: (4) Type and model B-17 (5) Serial No. 43-38721 (6) Station AAF 106  
Organization: (7) 8th (8) 38th Bomb (H) (9) 545th Bomb (H) (10) 2357  
(Command and Air Force) (Group) (Squadron)

(53) Nature of accident Landing accident - pilot came in too fast and landed long, crashing into ship on runway.

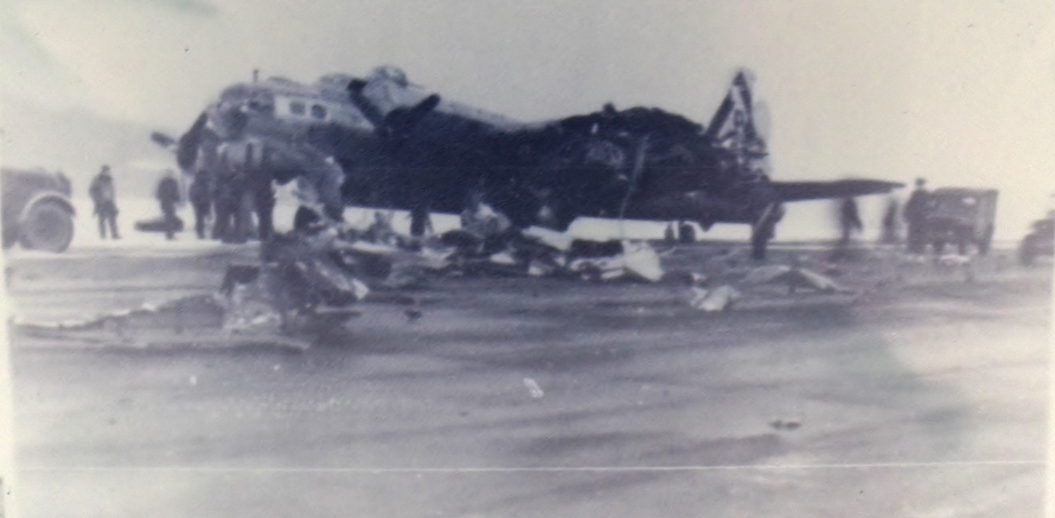
W.D-384-105-1X(22J3n45)(VC42-102620 E17G)

(56) Nature of accident Landing Accident, Aircraft was struck by a second B-17 that landed long and fast.

" Landed on runway 30 with no contact with tower on command or VHF. Fired red flares over field on downwind and final. Bombardier had flesh wound of right arm. Right wheel was locked and blew tire. Couldn't hold plane straight, so I started to turn off on to grass when we were hit from behind by a plane just landing. Men were injured in crash. Plane badly damaged left wing and rudder."
