U. S. ARMY AIR FORCES
REPORT OF AIRCRAFT ACCIDENT

(1) Place AAF Station 106 (2) Date 21 November 1944 (3) Time 1015
 AIRCRAFT: (4) Type and model B-17G (5) A. F. No. 42-102566 (6) Station 106
 Organization: (7) 8th (8) 38th Bomb (H) (v) 545th Bomb (H)
 (Command and Air Force) (Group) (Squadron)

SUBJECT: Opinion on Aircraft Accident B-17G 42-102566.

SUBJECT: Statement by Engineering Officer Concerning Accident Resulting in Salvage of Ship 42-102566.

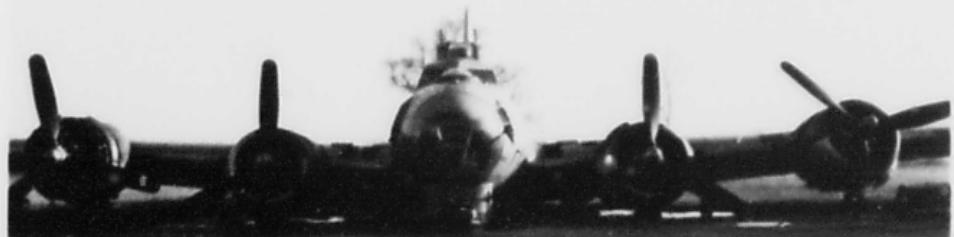
(GAD-88-1-384) (21-Nov-44) (7-2102566) Landing Gear Failure

The landing gear was retracted on the ground due to incorrect wiring while complying with TMI 01-20EF-36 dated 27 October, 1944. S/Sgt. Renshaw was wiring his first aircraft. The instructions in TMI 01-20EF-36 specifically states that the lead from the bus bar at Station Four (4) would be connected to the right hand side of the limit switch. The right terminal, however, was broken off and after several attempts to repair the terminal S/Sgt. Renshaw checked the drawing that accompanies the above TMI and decided the same effect would be gained by connecting the above mentioned lead to the left terminal on the limit switch. The drawing does indicate that the two (2) terminals are on a closed circuit. Without checking with the Squadron Technical, Line Chief, Engineering Officer, or further investigating the aircraft blueprints covering the installations in question, he connected the lead in question to the left terminal on the limit switch. When the battery and master switches were turned on to check the operation of the hydraulic pump the landing gear retraction motors also began to function. Before this was realized the landing gear had retracted too far to be stopped by cutting the switch. The aircraft fell to the hardstand. The impact resulted in extensive damage. The aircraft is suitable for salvage only.
